ROYAL AIRCRAFT ESTABLISHMENT FARNBOROUGH (ENGLAND)
HOLOGRAPHIC INTERFEROMETRY OF CFRP WING TIPS. (U)

Technical Report 78105

HOLOGRAPHIC INTERFEROMETRY OF CFRP WING TIPS

M. Marchant

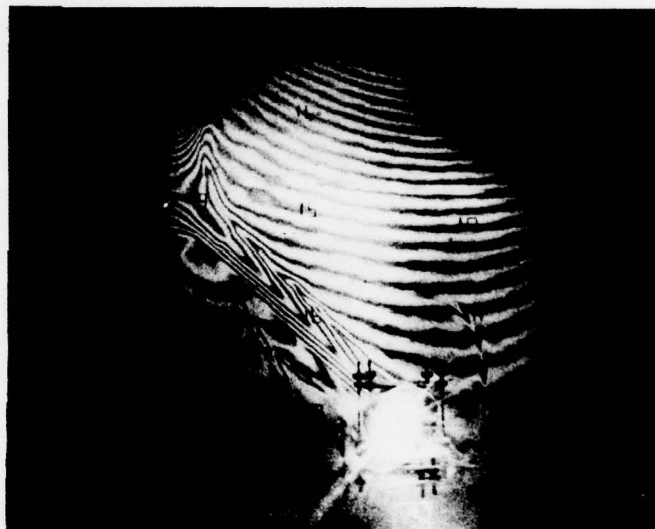
Figs 5a-c show the results obtained on the top surface of tip 8. This tip was received direct from the manufacturers and had had no previous tests applied to it. Some very prominent anomalies were found in all areas as well as traces of a straight line (above '10' and '15') similar to that on tip 6. It seemed just possible that this line might be due to some strain in the mounting, although the earlier tests had involved relocation, so a series of photographs was taken with the support rollers lower relative to the 3-point mount and then with the tip tilted through approximately 12° in each direction.

b Area 2 — various anomalies including line

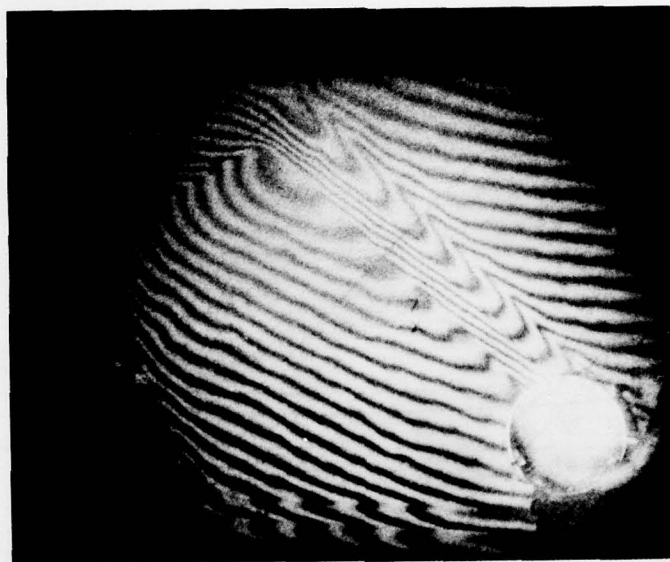
a Direct photograph of live fringes

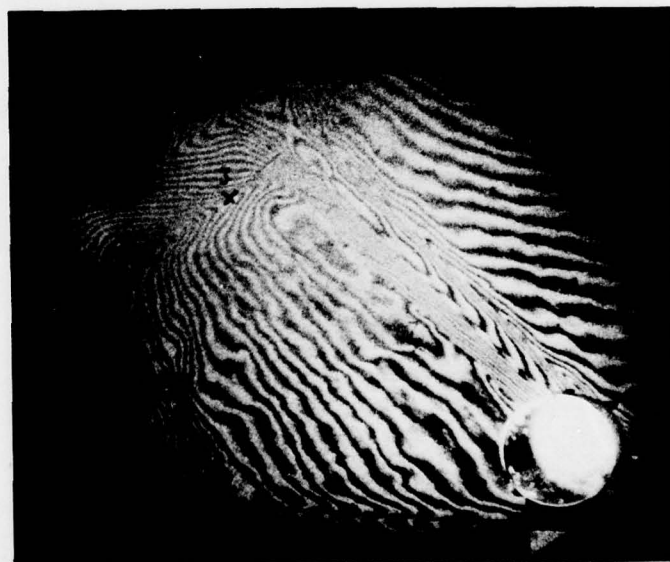
b From TV monitor

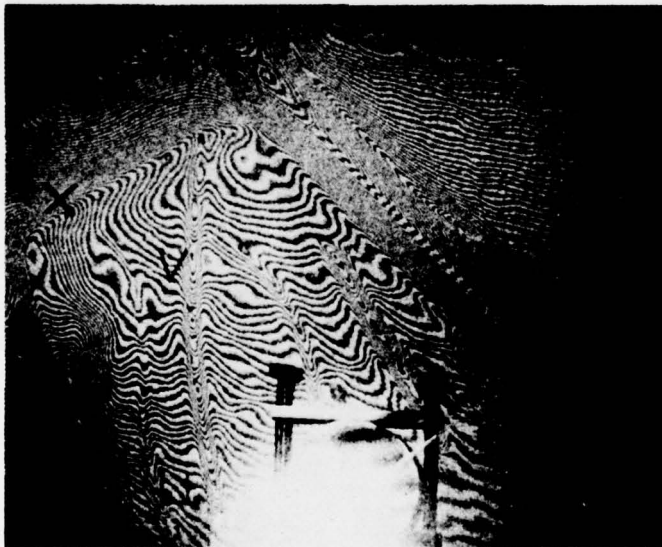
The set-up for examining the bottom surface was extremely stable and it was noticed that after some hours more skin laminae could be seen (Fig 8a is an example) and that later still the fringes developed a very irregular appearance (eg Fig 8b).

g After 4 hours —
compare Fig 8b
